# THE DUKES COUNTY INTELLIGENCER

## The Vincent House

*In 1977 the Martha's Vineyard  
Historical Preservation Society began  
restoration of one of the Island's  
earliest extant buildings, a farmhouse  
from the Edgartown Great Pond region.*

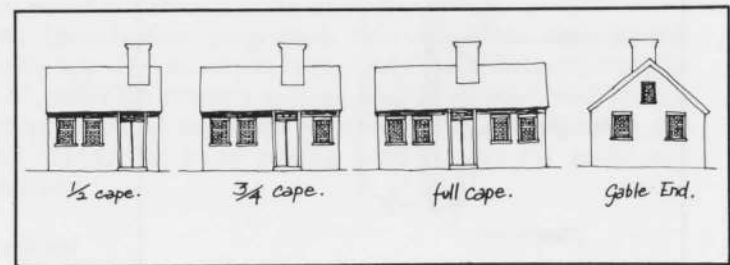
Figure 3

The present dimensions of the Vincent House (28' x 26') would have been considered large for 1656. The size of its full-Cape frame raised questions as to how much was actually original. Often the "full" shape of a Cape Cod design developed from a "half Cape" or from a "three-quarter Cape" by additions (Fig. 3). Therefore I expected to see that

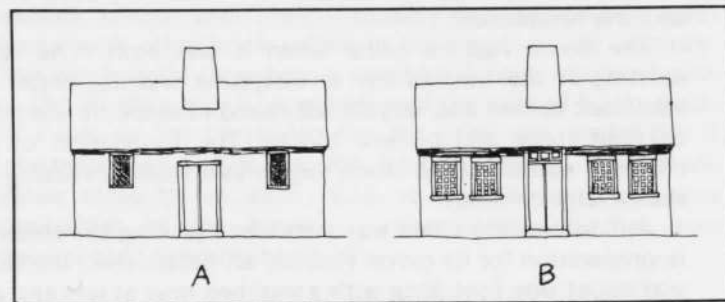
Figure 10

Fragments of quarrel glass were found near the house indicating that the house originally had diamond-paned, casement type windows. Diamond-paned glass was generally a very early type. Marks in the studs in the front rooms would indicate that there had been casement windows here. Two stud cuts were found but they had been cut differently. However, the location of the studs in the front rooms did indicate that there had been a single window in the center of each exterior wall. Two of these studs had the type of cut to which casements could be attached. Thus, in exterior appearance, the original structure was changed from Fig. 10A to Fig. 10B.
